GOLDWING SOLAR  
LEVEL 1 SITE LAYOUT AND EROSION CONTROL PLANS  
ADAMS COUNTY, COLORADO  
INTERSECTION OF PHILMAY RD AND E 152 AVENUE

# EXHIBIT 11 - DRAFT DECOMMISSIONING PLAN

# EXHIBIT 13 - PHASE I ENVIRONMENTAL SITE ASSESSMENT

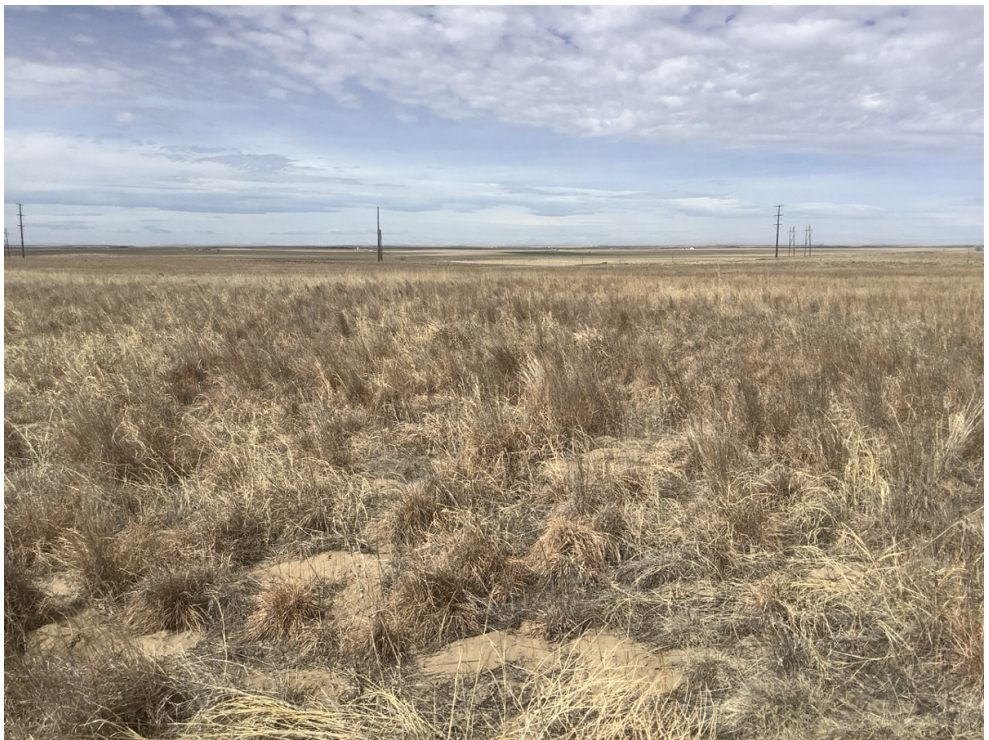
| <b>Photograph ID: 1</b> | | | |

| <b>Comments:</b><br>Representative photo of the primary habitat type (shortgrass prairie) found within the project area. | | | |

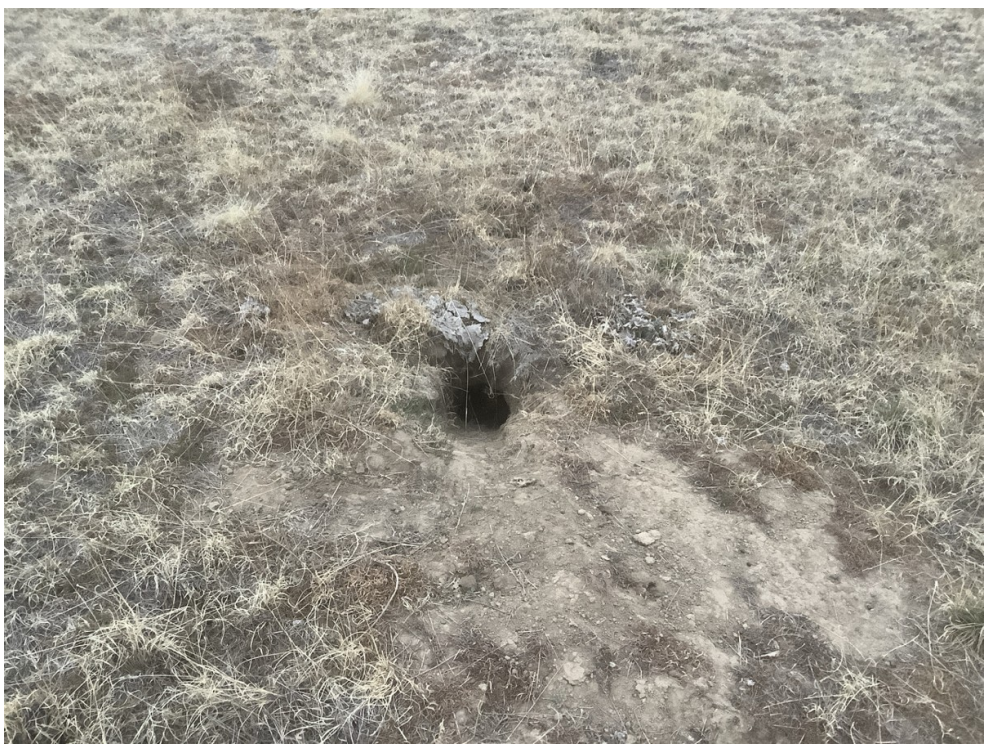
| <b>Photograph ID: 2</b> | | | |

| <b>Comments:</b><br>Representative photo of a single burrow found within the project area. | | | |

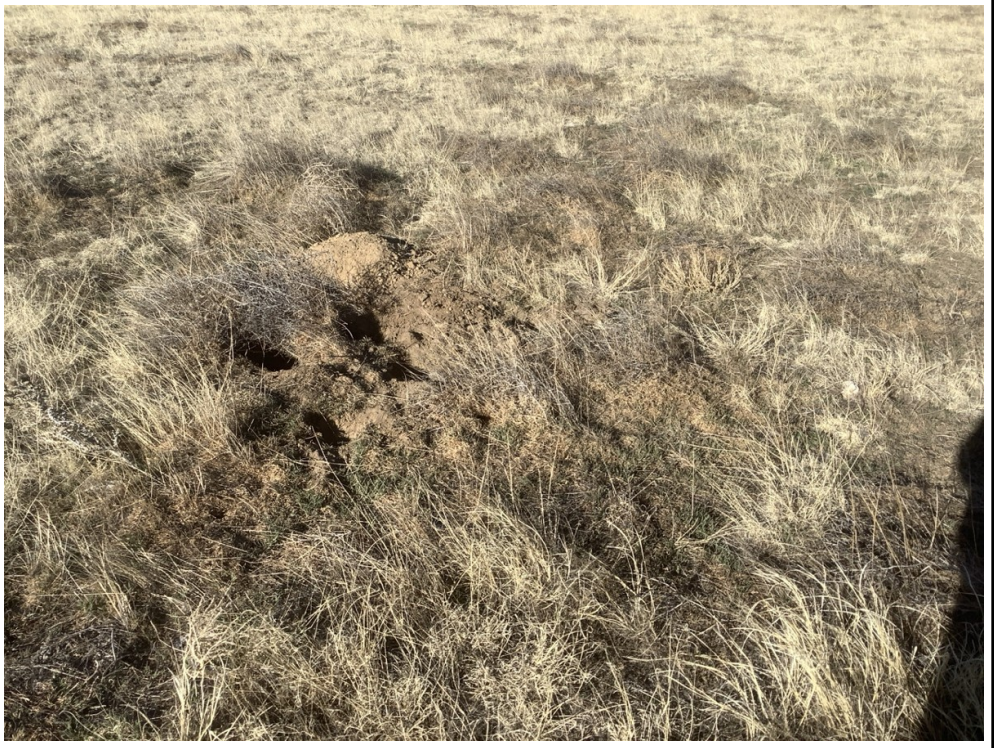
| <b>Photograph ID:</b> 3 | | | |

| <b>Comments:</b><br>Representative photo of a burrow complex found within the project area. | | | |

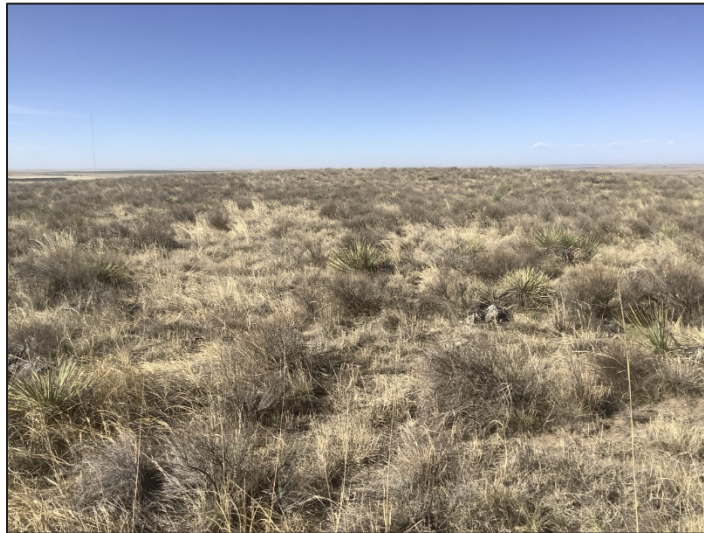
*Representative Photo of the Native Land Cover Found within the Project Area*

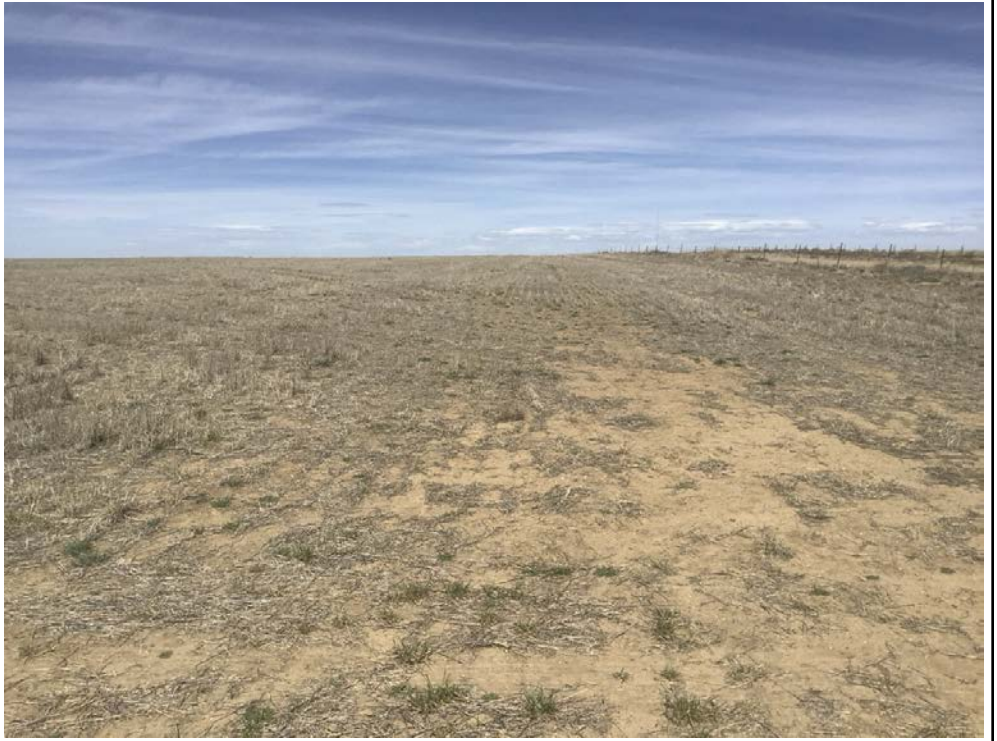
| <b>Photograph ID: 1</b> | | | |

| <b>Comments:</b><br>Representative photo of the Subject Property which is currently being used as rangeland for cattle grazing and production. | | | |

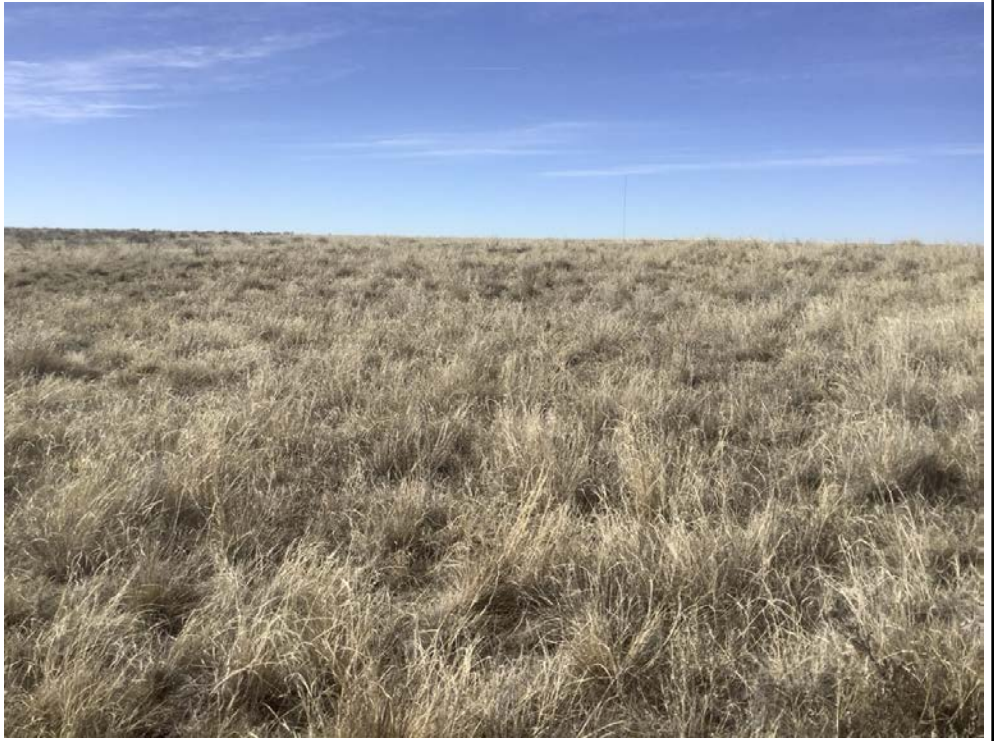
| <b>Photograph ID: 3</b> | | | |

| <b>Comments:</b><br>Adjacent land use which contains native prairie. This land type can be found to the northwest, north, south, and southeast of the Subject Property. | | | |

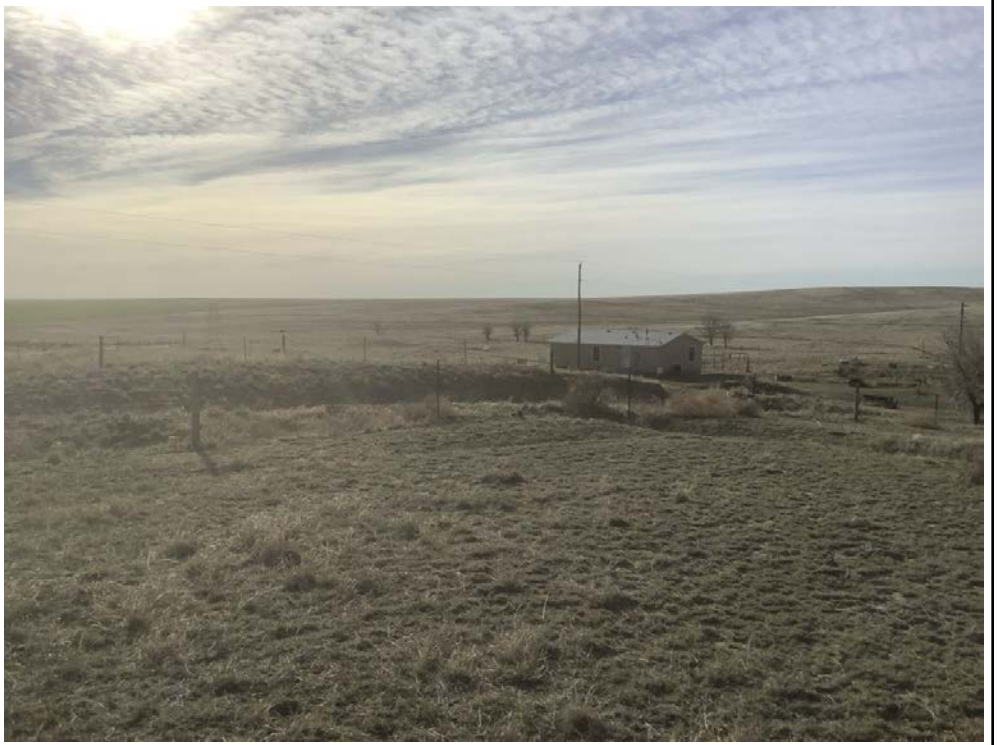
| <b>Photograph ID: 5</b> | | | |

| <b>Comments:</b><br>Adjacent land use which contains a single family residence. This land type can be found to the east of the Subject Property. | | | |

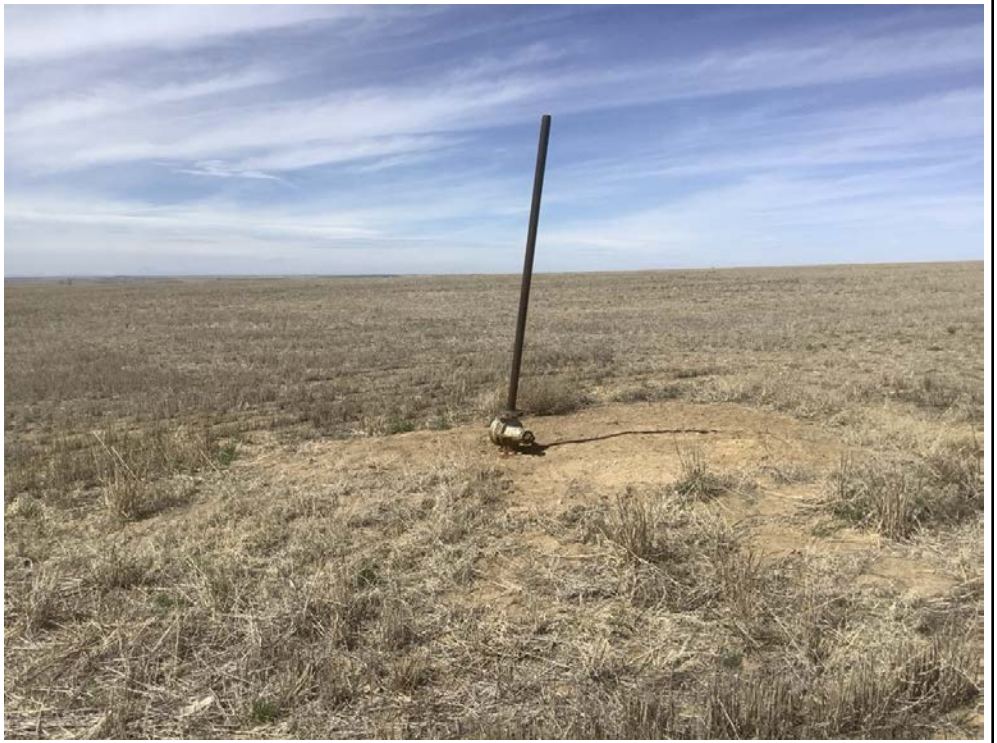
| <b>Photograph ID: 7</b> | | | |

| <b>Comments:</b><br>Mapped 1 PIERCE wellhead with equipment still in the ground. This equipment is located within the Subject Property. | | | |

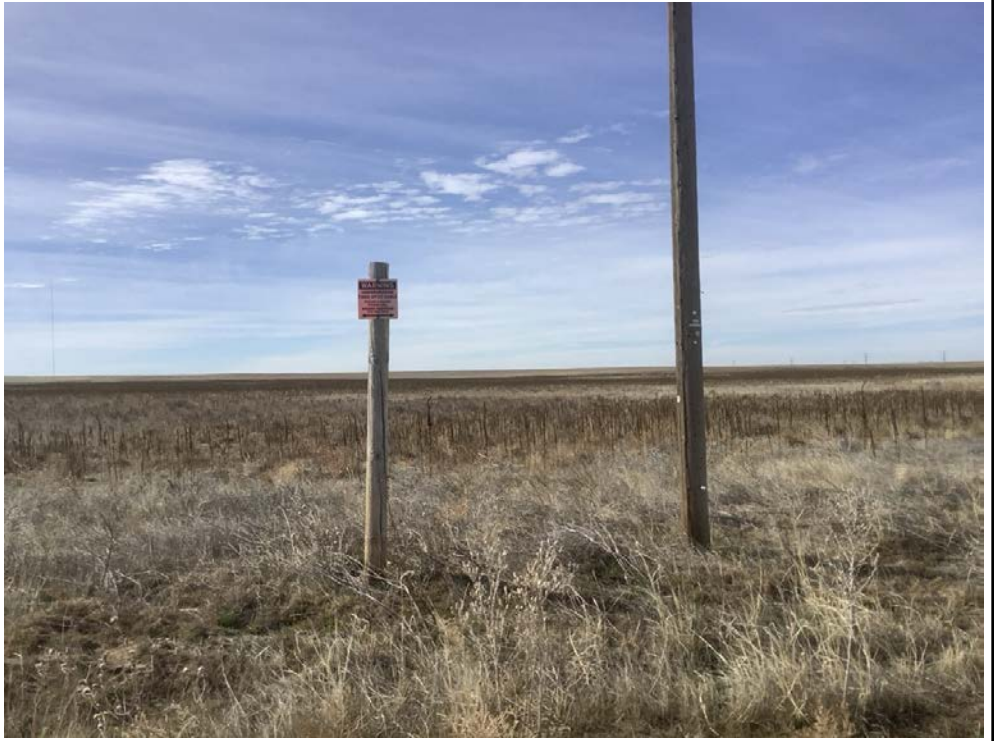
| <b>Photograph ID: 9</b> | | | |

| <b>Comments:</b><br>Underground fiber line indicator located within the Subject Property. | | | |

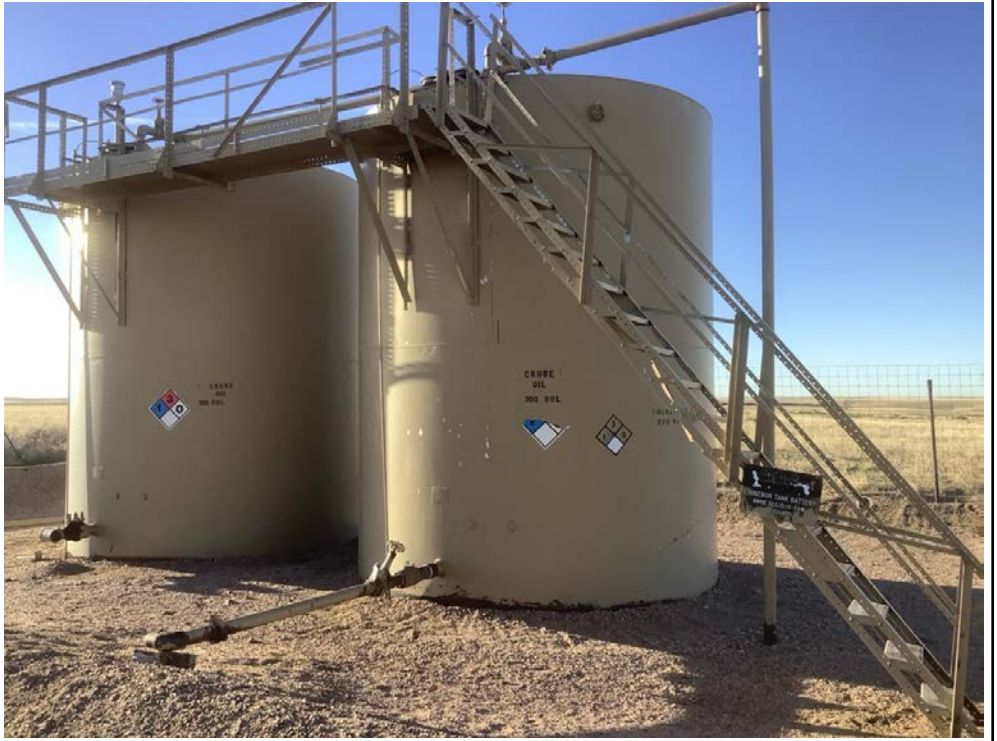
| <b>Photograph ID: 11</b> | | | |

| <b>Comments:</b><br>Tank battery for an assumed active oil and gas well located to the west of the Subject Property, immediately south of the Cattle Operation property. | | | |

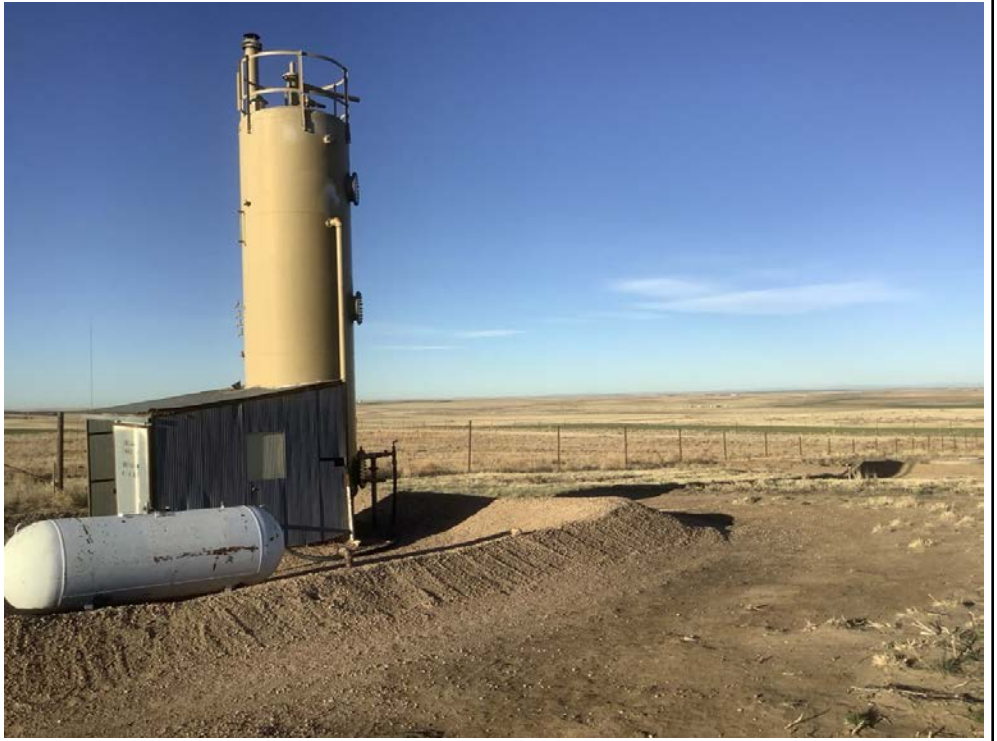
| <b>Photograph ID: 13</b> | | | |

| <b>Comments:</b><br>Tank battery for an assumed active oil and gas well located to the west of the Subject Property. | | | |

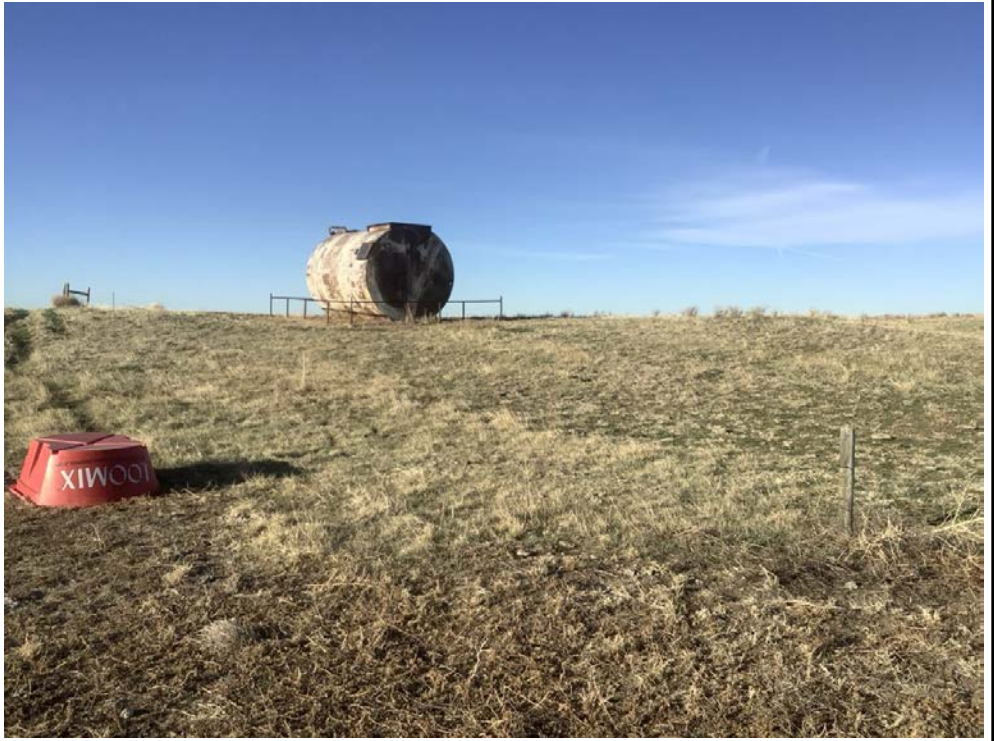
| <b>Photograph ID: 15</b> | | | |

| <b>Comments:</b><br>Unidentified AST with an unknown purpose located on the property to the West of the Subject Property. The AST was located near a cattle water tank and may be used for livestock purposes. | | | |

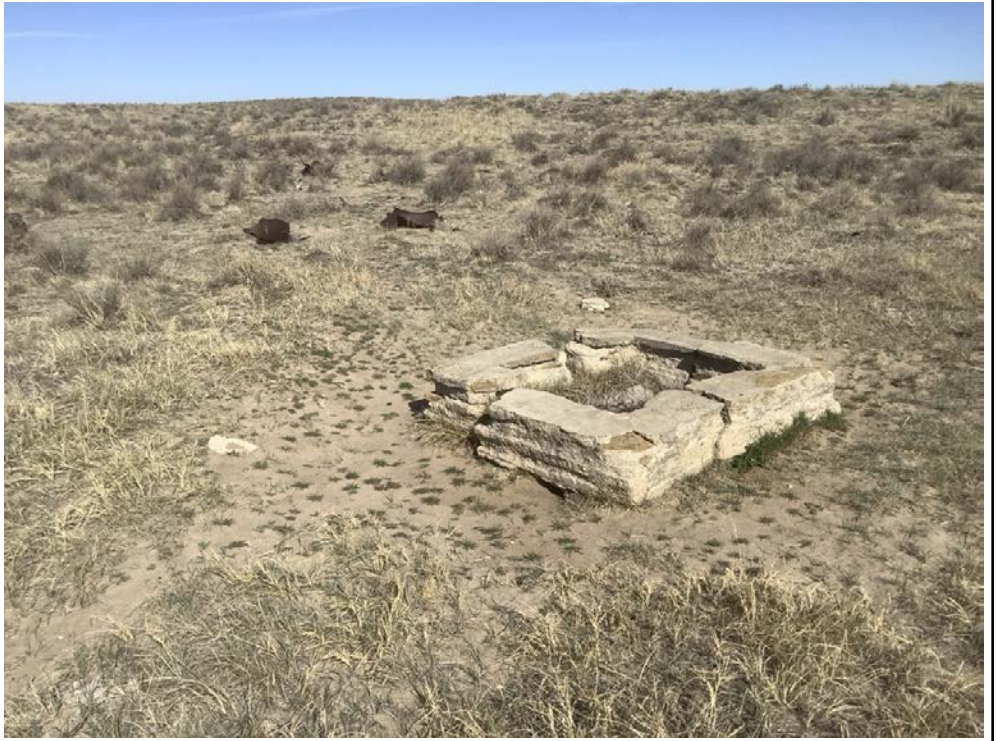
| <b>Photograph ID: 17</b> | | | |

| <b>Comments:</b><br>Concrete foundation and trash located within the Subject Property. | | | |

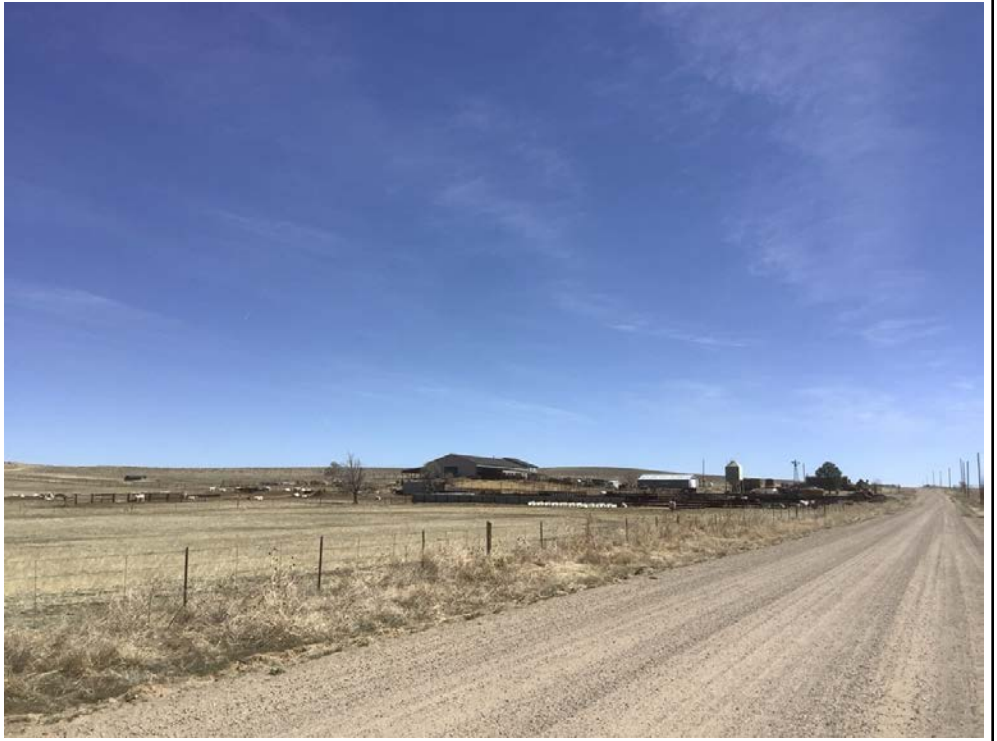
| <b>Photograph ID:</b> 19 | | | |

| <b>Comments:</b><br>Active cattle operation located on a west adjoining property. | | | |

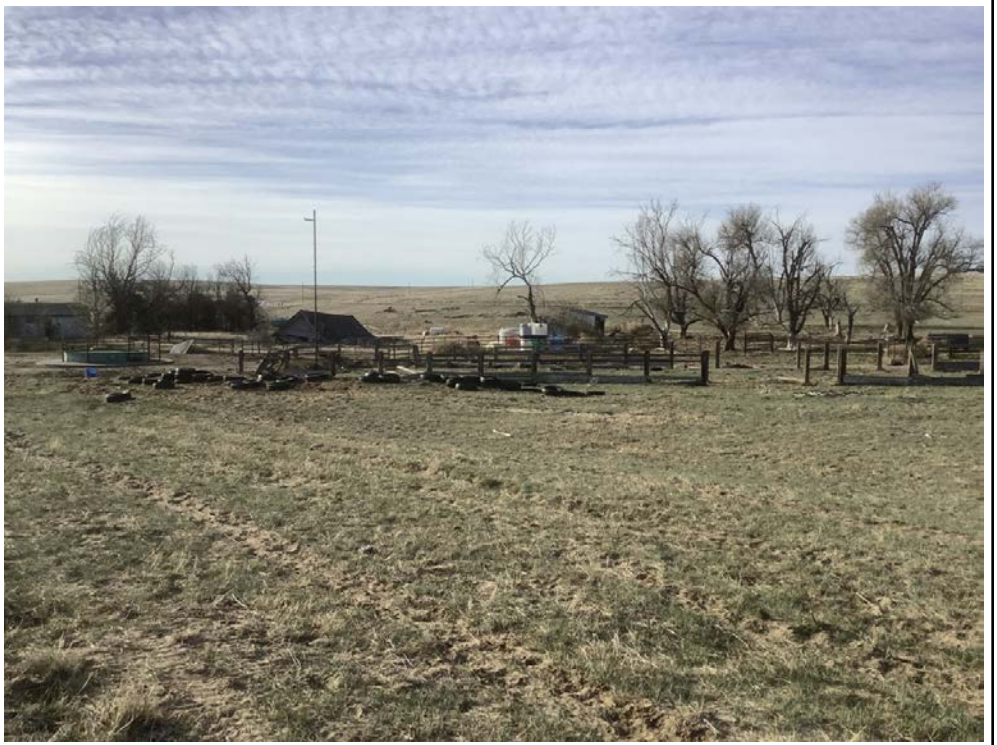
| <b>Comments:</b><br>An abandoned farmstead located along the eastern Subject Property boundary. Dumping of tires, totes, ASTs, and a boat was observed. | | | |

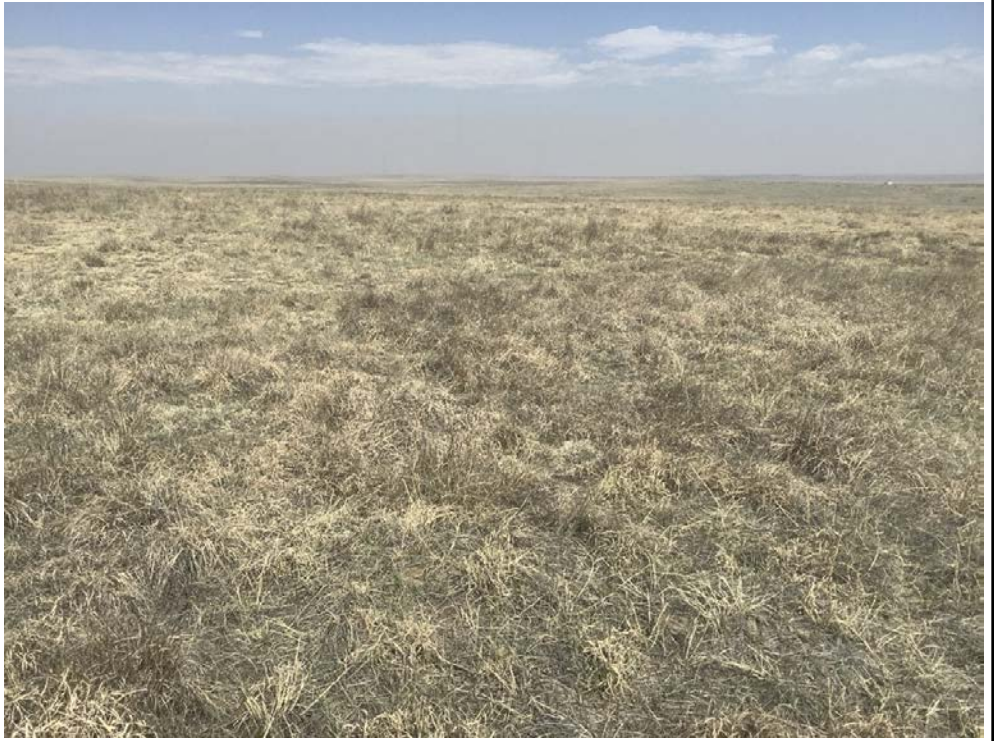
| <b>Photograph ID: 23</b> | | | |

| <b>Comments:</b><br>Mapped Strata Production Operations 1 POTTY BROWN well located within the subject property. No evidence of a well was present during the site investigations. | | | |

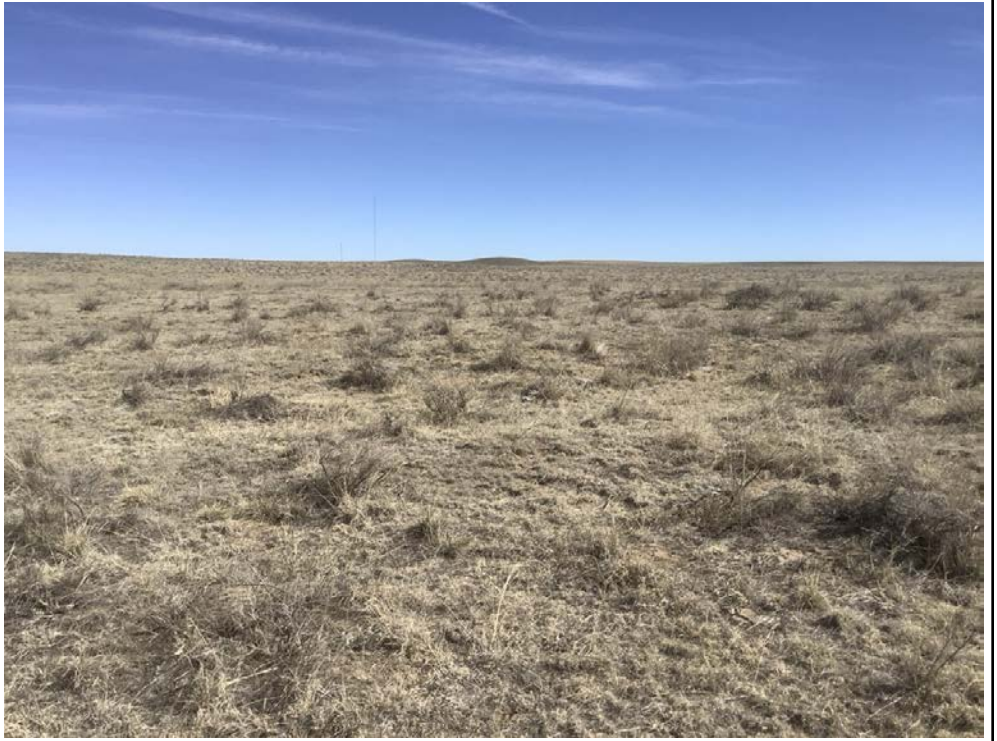
| <b>Photograph ID: 25</b> | | | |

| <b>Comments:</b><br>Mapped Kimbark Oil & Gas Company 1 BARBER well located within the subject property. No evidence of a well was present during the site investigations. | | | |

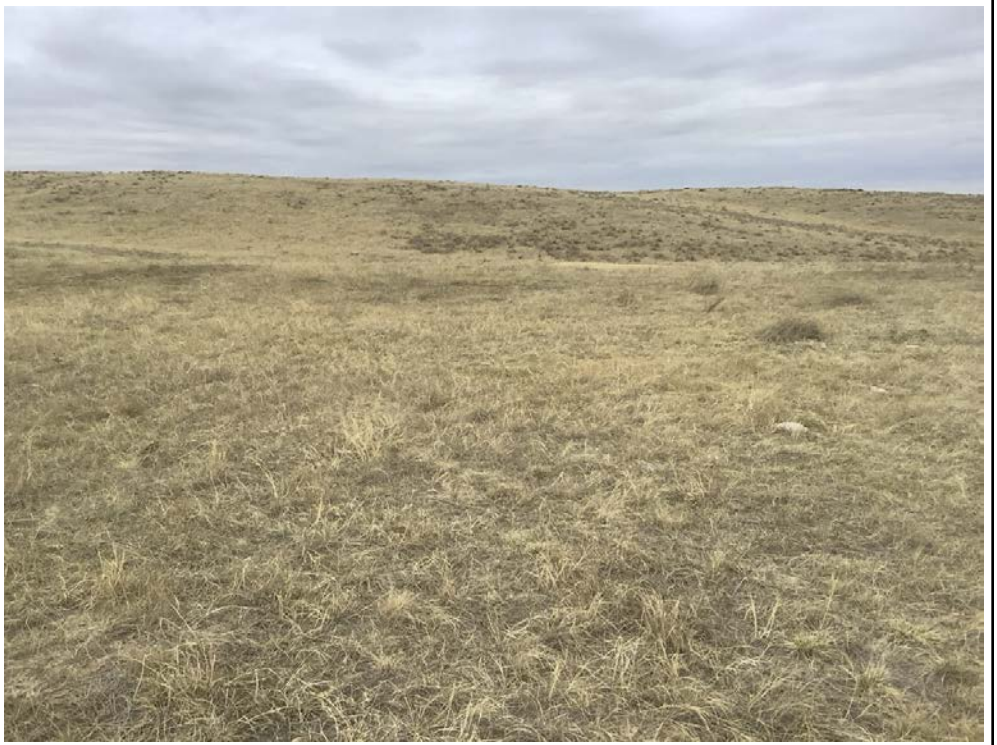
| <b>Comments:</b><br>Mapped Griffin Bennie C 44-18 JENNIFER well located within the subject property. A former leveled pad site was evident during the site investigations, however, no stressed vegetation or signs of spills were present. | | | |

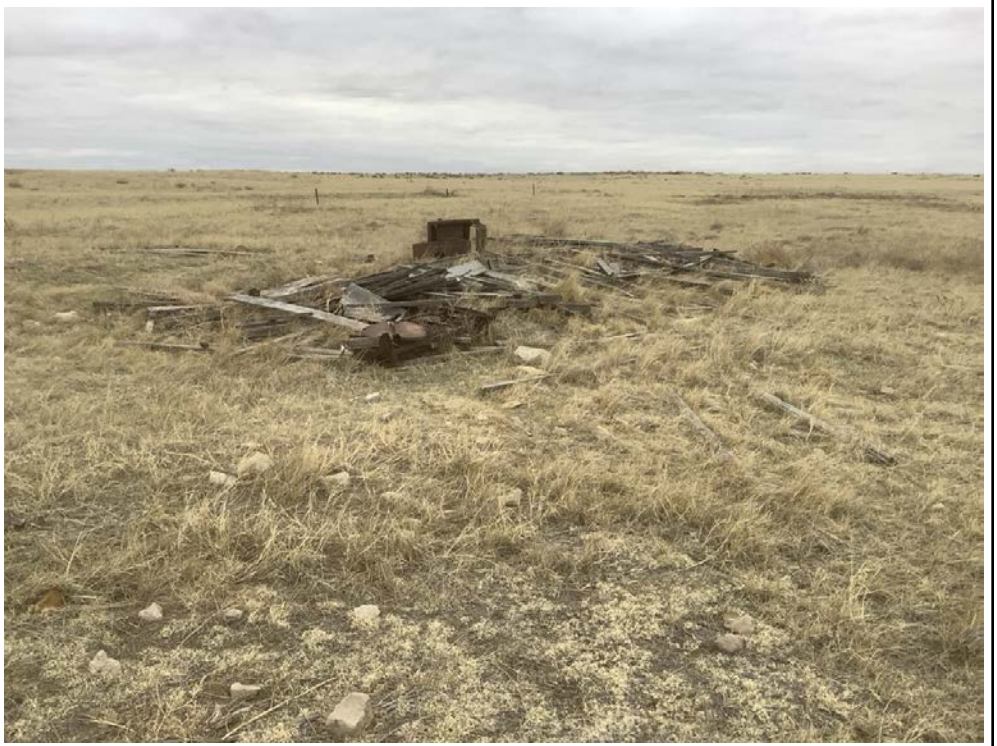
| <b>Photograph ID:</b> 30 | | | |

| <b>Photo Location:</b><br>Subject Property -<br>(39.956921, -103.922128) | | | |
| <b>Direction:</b><br>Northeast | | | |

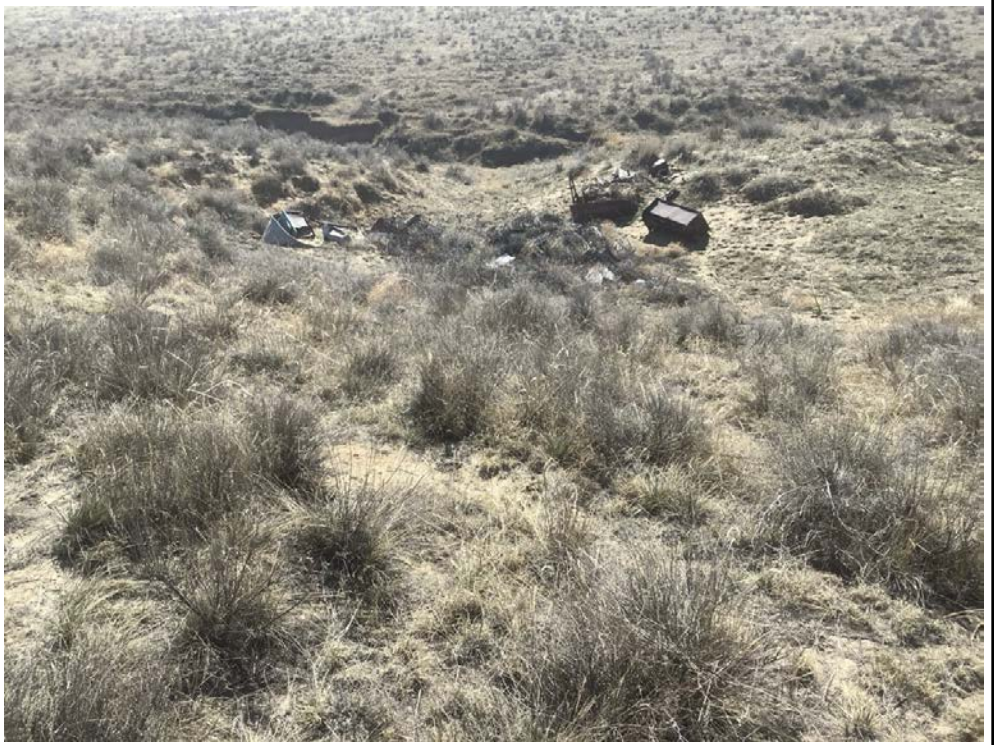
| <b>Photograph ID:</b> 31 | | | |

| <b>Photo Location:</b><br>Subject Property -<br>(39.975400, -103.919885) | | | |
| <b>Direction:</b><br>Southeast | | | |
| <b>Survey Date:</b><br>3/26/2026 | | | |
| <b>Comments:</b><br>Unidentified dumping located within the Subject Property. | | | |

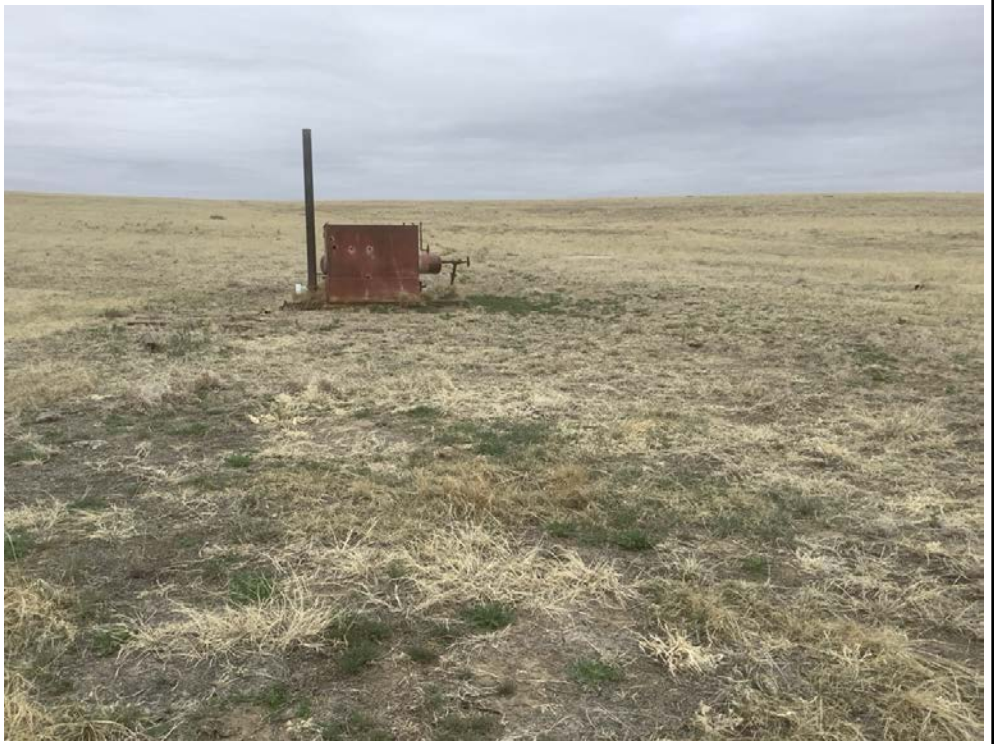
| <b>Photograph ID:</b> 32 | | | |

| <b>Photo Location:</b><br>Subject Property -<br>(39.96156, -103.903998) | | | |
| <b>Direction:</b><br>Northwest | | | |

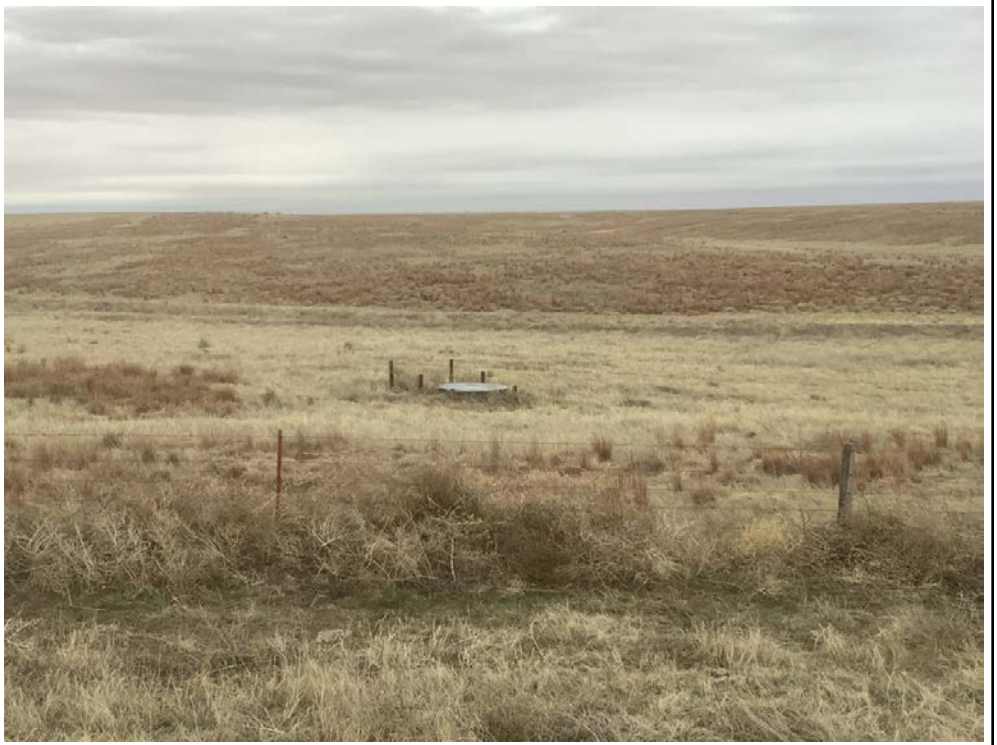
| <b>Photograph ID:</b> 33 | | | |

| <b>Photo Location:</b><br>South Adjoining Property -<br>(39.956413, -103.922556) | | | |
| <b>Direction:</b><br>South | | | |
| <b>Survey Date:</b><br>3/27/2026 | | | |
| <b>Comments:</b><br>Concrete pad with visible vent pipes located on a south adjoining property, immediately south of the southern dumping area on the Subject Property. | | | |

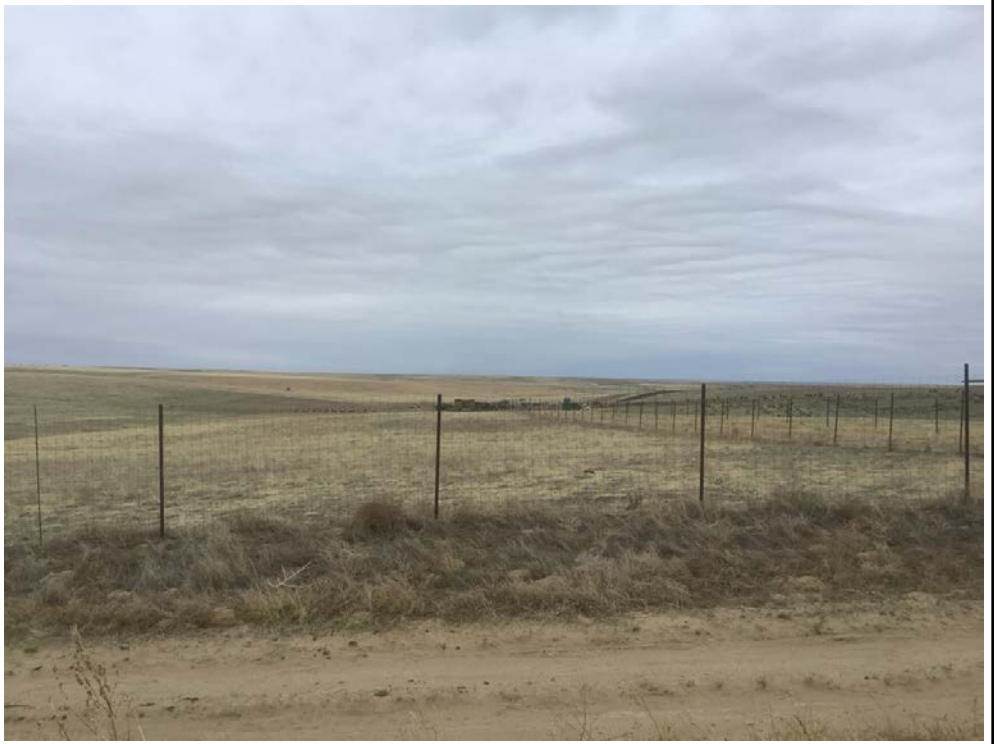
| <b>Photograph ID:</b> 34 | | | |

| <b>Photo Location:</b><br>West Adjoining Property -<br>(39.960443, -103.929196) | | | |
| <b>Direction:</b><br>West | | | |

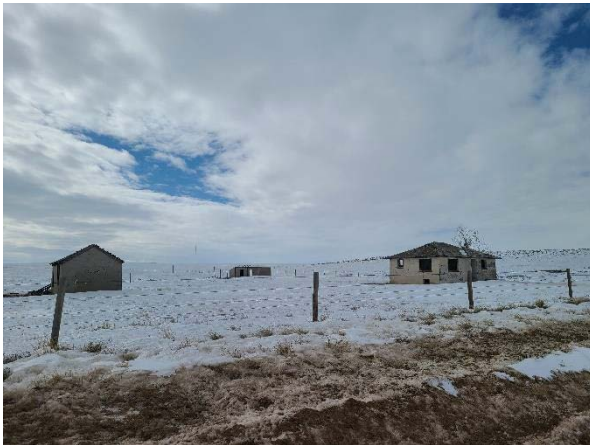
Photo 3 View of abandoned buildings along the northern boundary.

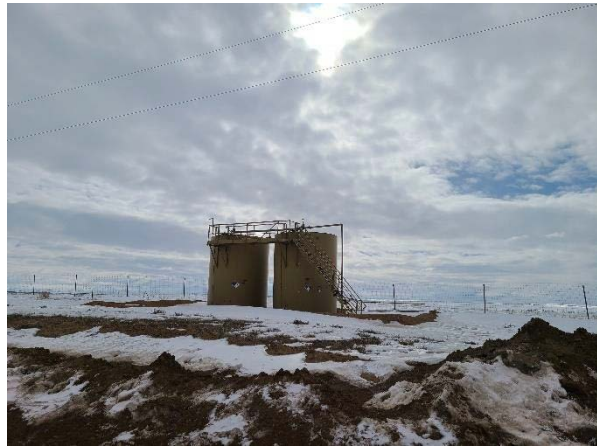
Photo 12 View of a west adjoining ASTs associated with oil/gas operations.

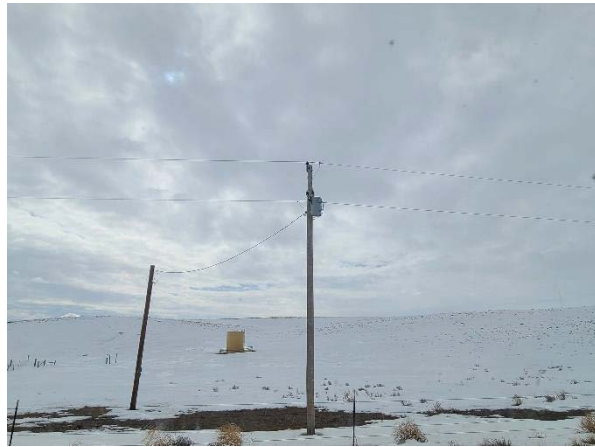
Photo 18 View of on-site AST and former oil and gas operation.
